Manhole Inspection Summary

Manhole # S29EE2012MH

Insp Date: **12/5/06 8:43 AM**

Location Address: **5710 STONY RUN DR**

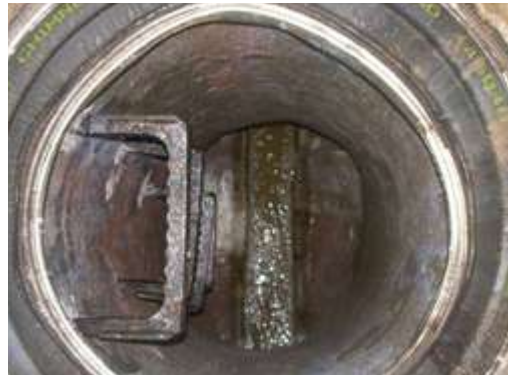
Top View

Bench ☒ Exists Material: **Unknown** ☐ Parged ☒ **Debris** (not Condition related)

Bench debris.

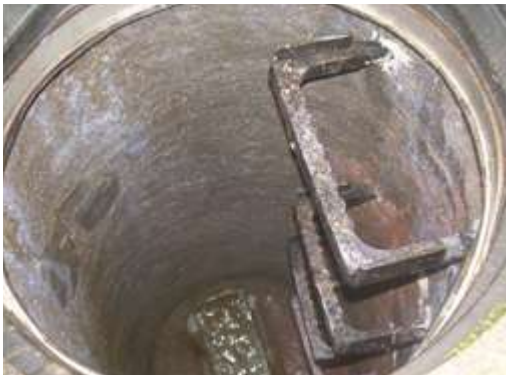
Defect

Frame Offset: **0** (in.) Condition: ☐ Sound ☐ Cracked ☒ **Leaks**

Infiltration: ☐ None ☒ **Joint** ☐ Cracks ☐ Mortar ☐ Roots ☒ **Wall**

Frame leaks. Adjustment infiltration - other side.

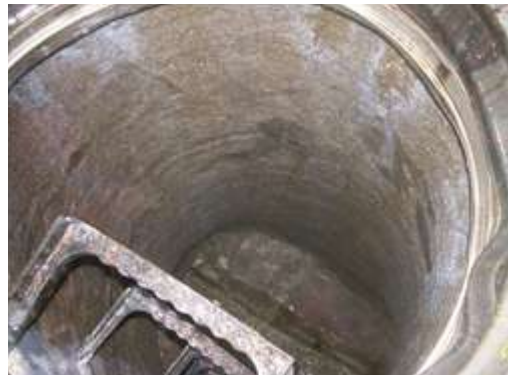
Defect

Frame leaks. Adjustment infiltration.

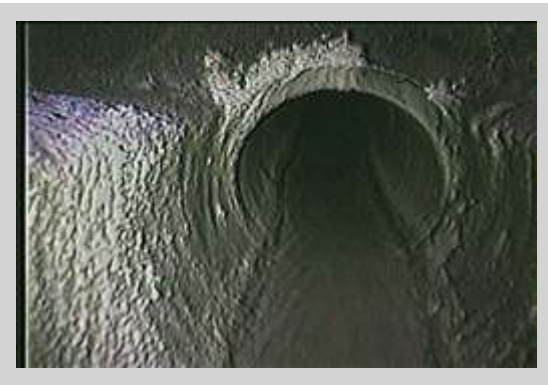
15 in. Circular Gravity Sewer Pipe Out @ 12 O'Clock

Infiltration Around Pipe

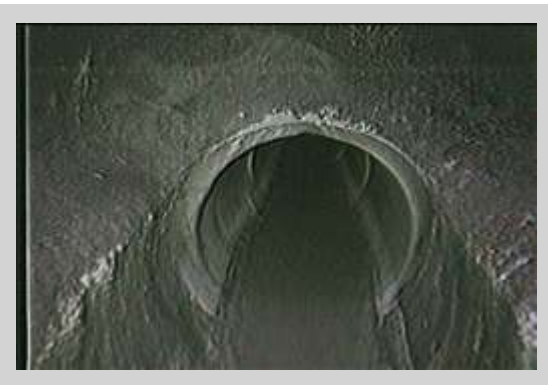
18 in. Circular Gravity Sewer Pipe In @ 6 O'Clock

Infiltration Around Pipe
